List of measures WMI recommended during an irrigation audit in Southern Nevada:

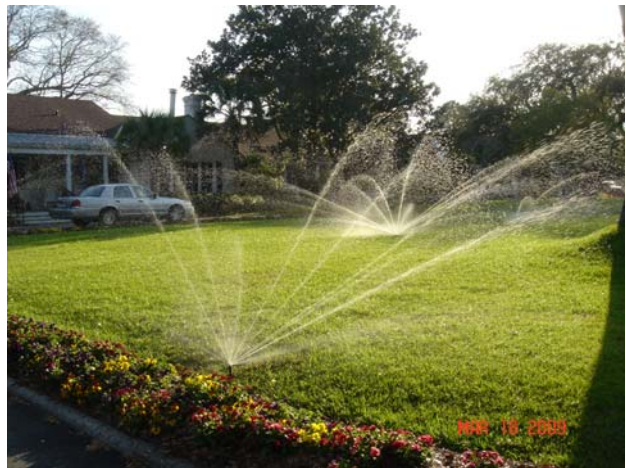
The MP Rotator's multi – trajectory, revolving streams apply water much more slowly and uniformly than conventional sprays. Independent audits have shown that water usage can be reduced by up to nearly one-third of current levels than what conventional sprays are replaced with MP Rotator sprinklers. Additional water saving advantages includes better wind-resistance, less misting, and the ability to handle reclaimed water. The application rate is approximately 1.5 to 2.5

inches per hour. Because soils are very compacted in most areas, run off of water starts to occur within 5 to 10 minutes after cycle starts. The rotating nozzle applies water at a rate of .5 inches per hour and works more effectively at lower pressures, resulting in increased distribution uniformity. Also the narrow streams of water are much more wind resistant. The MP-Rotator nozzle works more effectively at lower pressures than a gear driven rotor and the distribution uniformity improves if spaced appropriately.

- 3) Replace existing spray heads and nozzles with MP-Rotator nozzles with 40 PSI pressure regulation spray bodies.**

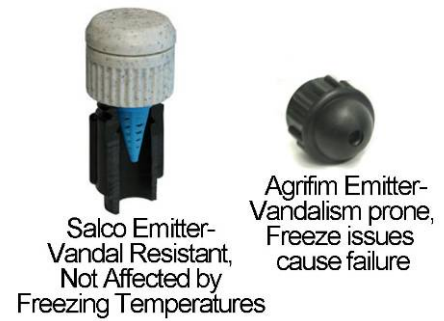
During the audit process it was noted at least one emitter or several emitters were broken on each of the xeriscape landscape irrigation zones. WMI witnessed cracked or broken emitters flowing at a rate of 2 to 8 gallons per minute per cycle. If these zones were repaired or retrofitted, water savings would be achieved.

8) Replace broken and old Agrifim emitters with Salco emitters in xeriscape planting zones.

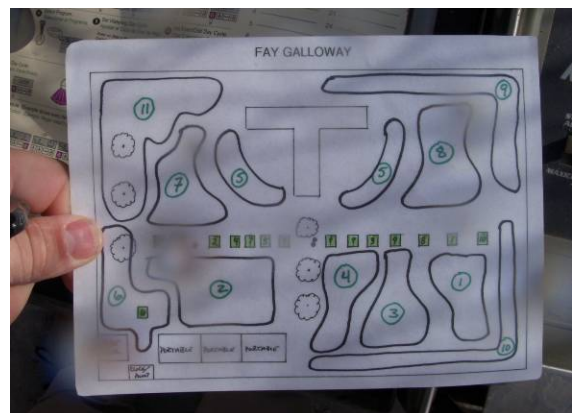
When a new irrigation technician tries to remember the location of all the irrigation zones, without updated as-builds, they tend not to be familiar with the areas of coverage. If accurate GPS mapping of the heads and zones are provided to them in electronic format, it will allow them to become familiar with their system. This would prevent the water loss due to unfamiliarity with the system.

13) Aerial mapping of all zones per clock and associate records for easy field checking.

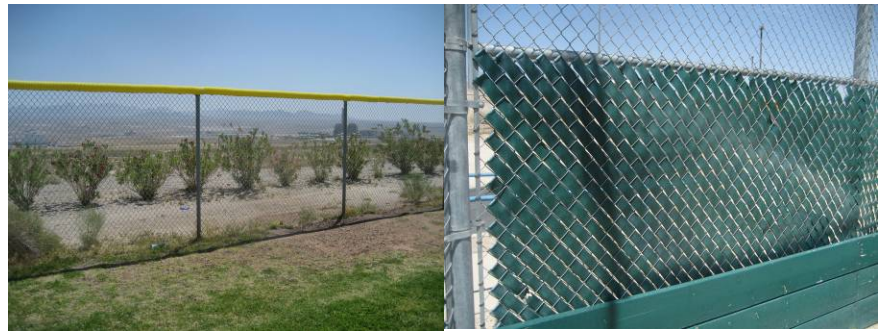
On some of the baseball fields, slats have been installed in the chain link fence. This enhancement makes the irrigation systems perform better with less wind distortion and water loss. Slats need to be installed on all field fences where possible.

The elementary school and high school in Laughlin, NV need the baseball slats and trees/ shrubs screens to stop some of the continuous wind. Water is lost in the irrigation system as a result of evaporation and wind drift. The water loss is high in these locations. Installing several layers of trees as well as more oleander bushes with associated subsurface irrigation would be beneficial to conserving water.

15) Plant trees around the perimeter of the field with associated subsurface irrigation system and put in slats on all field fences where possible to further prevent water loss due to wind drift and evaporation.

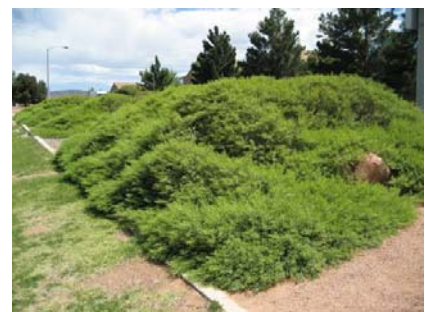
A shrub planted in the landscape known by common name Centennial Broom grows quickly and makes a branching pattern close to the ground creating a difficult situation for repairing broken irrigation systems below the plant. The shrub is small when installed in the landscape but after only a short time a few of these shrubs grow together and create one large dense mass planting. Broken emitters can leak for several months without any detection. Future landscape specification for school landscapes should prohibit plants that are hard for the irrigation technicians to repair the irrigation system.

16) Removal of Plants which require extensive labor to repair irrigation systems.

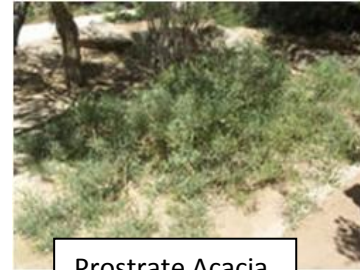
Prostrate Acacia

An alternative plant to use would be the Desert Carpet or Prostrate Acacia, which has a larger footprint at maturity but a less dense branching pattern and is easier to repair broken irrigation components. In the 30 schools, 28 Centennial Broom dense shrubberies were found with broken irrigation components beneath and a virtually impossible way to get at the break and fix it. WMI estimates a total of 500,000 gallons of water is lost per year due to broken components beneath these shrubs that goes undetected. The system could be modified to subsurface where it would have less chance of breaking.

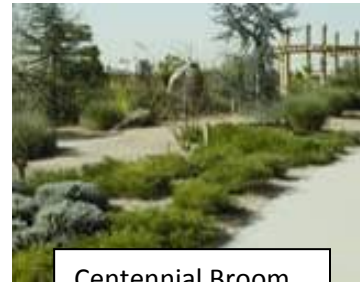
This Centennial Broom shrub creates additional work for the irrigation technicians, time to remove the plant to get to the broken irrigation component. In a number of situations, this problem has occurred and the repair is not done due to time constraints.
