BEN ALTAMIRANO FIELD

SILVER CITY, NEW MEXICO

As part of its efforts to control costs and conserve water for their town, The Town of Silver City New Mexico hired Water Management Inc. to implement water efficiency upgrades at one of their public fields. Water Management Inc. was tasked with installing a new “Smart Irrigation” system at the Ben Altamirano Ball Fields. The completion date for installation was August 1, 2013.

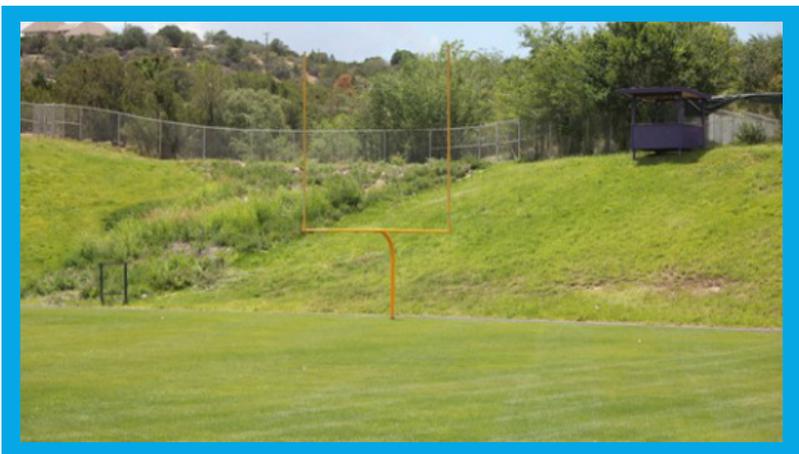
The scope of work consisted of installing a new weather based irrigation controller and retrofitting the existing rotors with new rotors that had a further throw of water and operated more efficiently at a lower pressure. A flow sensor was installed to record breaks in the mainline, missing rotors or breaks in the system. Prior the installation of the new system, a detailed audit was compiled a TDR testing. The results from the TDR testing are shown to the below. Wind screening is the most noticeable problem the field had prior to our program, with the dark blue showing an area with double wind screening on the outside fence which stops almost all of the wind, so the soil is not dried out as quickly. Broken heads were also noted by the dark spot on the JV Girls Baseball field. Effects from a solid cinder block wall can be seen on the Soccer field in the middle of the fields, a line of three light blue dots exist showing blockage of irrigation spray.

The overall sports complex had a DU of 61.9%. The Varsity Baseball Infield had the best distribution uniformity of all at 75.9% and the outfield had the worse DU at 55.4%. The throw of each rotor ideally needs to reach the other irrigation heads next to the rotor in order to have head to head coverage, the rotors on spaced such and have a nozzle size the keeps the radius of each water arc to 50 feet and the spacing of the rotors is 60 feet. This usually is adequate in non-windy situations; however on these fields the winds are high and cause high wind deflection. A next larger nozzle needs to be used. In some cases the nozzle size is simply not correct for the arc of the rotor and the landscape covered. The installation of the “smart” controller will eliminate this condition from occurring.
